**Resolution for River North Landmarks  
Attachment A**

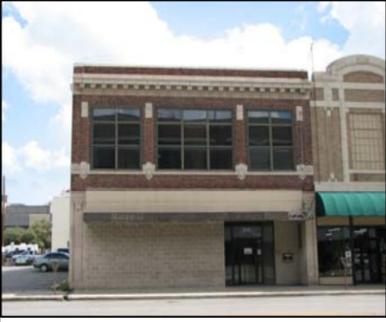
2	310 Broadway <b>Firestone Tire and Rubber Building</b>

The two-story brick commercial building at 310 Broadway adjoins the neighboring property at 212 3 <sup>rd</sup> Street. Both buildings were constructed in 1917 and designed by architect H.A. Reuter. The building functioned as the Firestone Tire and Rubber and later Firestone Tire Auto Supply through at least 1935. Although the ground floor façade has been enclosed, the upper floor retains architectural integrity of design, materials, and workmanship with decorative pilasters at either edge of the ground floor façade, a decorative cornice with heavy dentils, and decorative concrete elements between the windows of the upper floor. The building reflects the early automotive history of the Broadway corridor and continues to convey its architectural significance as an early twentieth century commercial structure.	<b>35-607 (b) 1.</b> Its value as a visible or archeological reminder of the cultural heritage of the community, or national event: automobile industry and early 20 <sup>th</sup> century commercial development; <b>35-607 (b) 5.</b> Its embodiment of distinguishing characteristics of an architectural style valuable for the study of a period, type, method of construction, or use of indigenous materials; <b>35-607 (b) 7.</b> Its unique location or singular physical characteristics that make it an established or familiar visual feature: part of the automobile corridor of Broadway; part of the early 20th century commercial development of the Broadway corridor; <b>35-607 (b) 8.</b> Its historical, architectural, or cultural integrity of location, design, materials, and workmanship; <b>35-607 (b) 11.</b> It is distinctive in character, interest, or value; strongly exemplifies the cultural, economic, social, ethnic, or historical heritage of San Antonio, Texas, or the United States: automobile industry (culture) and early 20 <sup>th</sup> century commercial development of the city; <b>35-607 (b) 12.</b> It is an important example of a particular architectural type or specimen: early 20 <sup>th</sup> century commercial construction	X	X		1

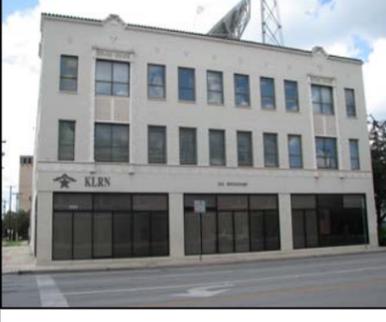
3	501 Broadway (501-507 Broadway) <b>San Antonio Buick Building</b>

The three-story commercial building at 501 Broadway (at the corner of Broadway and McCullough) was constructed in 1924 and designed by the prolific San Antonio architectural firm of Adams & Adams. From the 1920s through about 1950 the building served as the San Antonio Buick Company. Today, it is home to San Antonio's KLRN television station. The building features elements of the Spanish Revival style with delicate columns and finials and bas relief ornament at two of the window bays. A stringcourse of ornamental swags, medallions over the upper floor windows, small curved parapets, and tile coping also reflect the Spanish Revival influence. The architectural firm of Adams and Adams designed buildings in San Antonio and throughout Texas in the early to mid-twentieth century, including Jefferson High School on the city's near northwest side. The building retains high architectural integrity of design, materials, and workmanship.	<b>35-607 (b) 1.</b> Its value as a visible or archeological reminder of the cultural heritage of the community, or national event: automobile industry and early 20 <sup>th</sup> century commercial development; <b>35-607 (b) 4.</b> Its identification as the work of a master builder, designer, architect, or landscape architect whose individual work has influenced the development of the community, county, state, or nation: Adams & Adams; <b>35-607 (b) 5.</b> Its embodiment of distinguishing characteristics of an architectural style valuable for the study of a period, type, method of construction, or use of indigenous materials; <b>35-607 (b) 7.</b> Its unique location or singular physical characteristics that make it an established or familiar visual feature: part of the automobile corridor of Broadway; part of the early 20th century commercial development of the Broadway corridor; <b>35-607 (b) 8.</b> Its historical, architectural, or cultural integrity of location, design, materials, and workmanship; <b>35-607 (b) 11.</b> It is distinctive in character, interest, or value; strongly exemplifies the cultural, economic, social, ethnic, or historical heritage of San Antonio, Texas, or the United States: automobile industry (culture) and early 20 <sup>th</sup> century commercial development of the city; <b>35-607 (b) 12.</b> It is an important example of a particular architectural type or specimen: early 20 <sup>th</sup> century commercial construction	X	X	Owner opposed	1

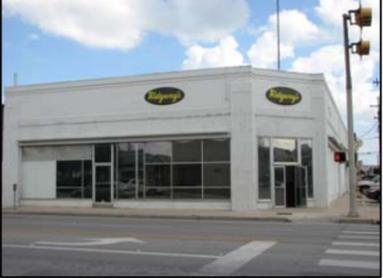
Property Address	Photo	Summary and Recommendation	Eligibility Criteria	OHP Staff Recommend	HDRC Recommend	Owner Response	Council District
4	600 Broadway (602 Broadway)

The one-story commercial structure at the corner of Broadway and 6 <sup>th</sup> Street was constructed ca. 1925. In the late 1920s it functioned as a Goodyear Service Station operated by the Swinebroad Auto Supply Company. It continued to operate as a filling station into the 1950s. The building features fluted pilasters at the angled corner entrance and building corners, a decorative organic-themed stringcourse, and a geometric swag cornice below the roofline. Like many of its neighbors, the building functioned as part of the automobile corridor of Broadway in the early to mid-twentieth century. It retains high architectural integrity of design, materials, and workmanship.	<b>35-607 (b) 1.</b> Its value as a visible or archeological reminder of the cultural heritage of the community, or national event: automobile industry and early 20 <sup>th</sup> century commercial development; <b>35-607 (b) 5.</b> Its embodiment of distinguishing characteristics of an architectural style valuable for the study of a period, type, method of construction, or use of indigenous materials; <b>35-607 (b) 7.</b> Its unique location or singular physical characteristics that make it an established or familiar visual feature: part of the automobile corridor of Broadway; part of the early 20 <sup>th</sup> century commercial development of the Broadway corridor; <b>35-607 (b) 8.</b> Its historical, architectural, or cultural integrity of location, design, materials, and workmanship; <b>35-607 (b) 11.</b> It is distinctive in character, interest, or value; strongly exemplifies the cultural, economic, social, ethnic, or historical heritage of San Antonio, Texas, or the United States: automobile industry (culture) and early 20 <sup>th</sup> century commercial development of the city; <b>35-607 (b) 12.</b> It is an important example of a particular architectural type or specimen: early 20 <sup>th</sup> century commercial construction	X	X		1

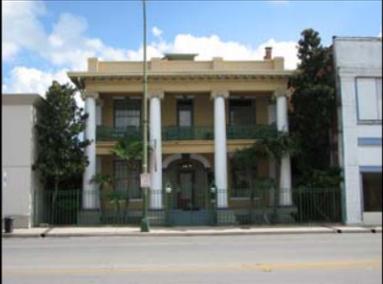
5	620 Broadway

The two-story Classical Revival style building at 620 Broadway was constructed ca. 1910. It functioned as an apartment house with "Modern Flats to Rent" in 1913, and in the late 1920s it was known as the Etter Apartments. Today, the building serves as the Painted Lady Inn Bed and Breakfast. The building retains high architectural integrity of design, materials, and workmanship, and it is one of the few surviving residential structures along this commercial section of Broadway.	<b>35-607 (b) 1.</b> Its value as a visible or archeological reminder of the cultural heritage of the community, or national event: early 20 <sup>th</sup> century residential construction; <b>35-607 (b) 5.</b> Its embodiment of distinguishing characteristics of an architectural style valuable for the study of a period, type, method of construction, or use of indigenous materials; <b>35-607 (b) 7.</b> Its unique location or singular physical characteristics that make it an established or familiar visual feature: part of the early 20 <sup>th</sup> century residential development of the area; <b>35-607 (b) 8.</b> Its historical, architectural, or cultural integrity of location, design, materials, and workmanship; <b>35-607 (b) 11.</b> It is distinctive in character, interest, or value; strongly exemplifies the cultural, economic, social, ethnic, or historical heritage of San Antonio, Texas, or the United States: early 20 <sup>th</sup> century residential development of the city; <b>35-607 (b) 12.</b> It is an important example of a particular architectural type or specimen: early 20 <sup>th</sup> century residential construction (Classical Revival)	X	X	Owner supports	1

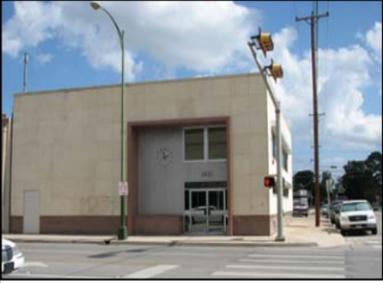
6	800 Broadway

The austere, stone-paneled commercial building at 800 Broadway was constructed in 1951 for Dean & Company, an auto finance company. It was designed by San Antonio architects Phelps, Dewees & Simmons, whose local work, in conjunction with other architects, included the Freeman Coliseum and Jefferson High School (Phelps & Dewees), among others. The "ultramodern...cut stone edifice," as described in early accounts, remains largely unchanged today. The clock on the façade is also original. When constructed, a newspaper article touted the building as "one of the most modern and attractive completed anywhere in recent years." At the time of construction, the building featured air-conditioning, two full stories, and a basement. In addition to its relationship with the automobile industry along the Broadway corridor, the building remains an outstanding example of mid-twentieth century modern commercial design and retains high architectural integrity of design, materials, and workmanship.	<b>35-607 (b) 1.</b> Its value as a visible or archeological reminder of the cultural heritage of the community, or national event: automobile industry and mid 20 <sup>th</sup> century commercial development; <b>35-607 (b) 4.</b> Its identification as the work of a master builder, designer, architect, or landscape architect whose individual work has influenced the development of the community, county, state, or nation: Phelps, Dewees, & Simmons <b>35-607 (b) 5.</b> Its embodiment of distinguishing characteristics of an architectural style valuable for the study of a period, type, method of construction, or use of indigenous materials; <b>35-607 (b) 7.</b> Its unique location or singular physical characteristics that make it an established or familiar visual feature: part of the automobile corridor of Broadway; part of the mid 20 <sup>th</sup> century commercial development of the Broadway corridor; <b>35-607 (b) 8.</b> Its historical, architectural, or cultural integrity of location, design, materials, and workmanship; <b>35-607 (b) 11.</b> It is distinctive in character, interest, or value; strongly exemplifies the cultural, economic, social, ethnic, or historical heritage of San Antonio, Texas, or the United States: automobile industry (culture) and mid 20 <sup>th</sup> century commercial development of the city; <b>35-607 (b) 12.</b> It is an important example of a particular architectural type or specimen: mid 20 <sup>th</sup> century commercial construction	X	X	Owner opposed	1

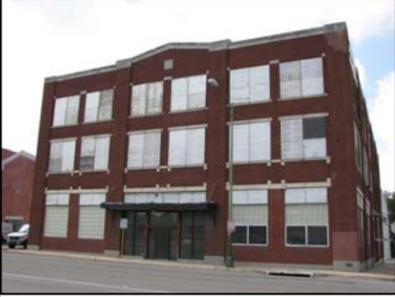
Property Address	Photo	Summary and Recommendation	Eligibility Criteria	OHP Staff Recommend	HDRC Recommend	Owner Response	Council District
7	931 Broadway (929-931 Broadway) <b>Buick Motor Building</b>

The three-story brick commercial building at Broadway and 10th Street was constructed in 1927 for Buick Motor Company. The letter "B" for Buick is incorporated into the decorative iron supports at the front entrance awning. The windows along the ground floor have been replaced, but the upper story windows are covered with metal louvers and may have been retained. The window opening configuration, however, including original transoms at the ground floor, has not been altered. The building features simple concrete lintels, a small, gabled parapet, and concrete coping. Its massing, location, and relatively intact façade continue to convey architectural significance as an early twentieth century commercial structure. It is significant also for its association with the early twentieth century automobile industry that developed along the Broadway corridor.	<b>35-607 (b) 1.</b> Its value as a visible or archeological reminder of the cultural heritage of the community, or national event: automobile industry and early 20 <sup>th</sup> century commercial development; <b>35-607 (b) 5.</b> Its embodiment of distinguishing characteristics of an architectural style valuable for the study of a period, type, method of construction, or use of indigenous materials; <b>35-607 (b) 7.</b> Its unique location or singular physical characteristics that make it an established or familiar visual feature: part of the automobile corridor of Broadway; part of the early 20th century commercial development of the Broadway corridor; <b>35-607 (b) 8.</b> Its historical, architectural, or cultural integrity of location, design, and workmanship; <b>35-607 (b) 11.</b> It is distinctive in character, interest, or value; strongly exemplifies the cultural, economic, social, ethnic, or historical heritage of San Antonio, Texas, or the United States: automobile industry (culture) and early 20 <sup>th</sup> century commercial development of the city; <b>35-607 (b) 12.</b> It is an important example of a particular architectural type or specimen: early 20 <sup>th</sup> century commercial construction	X	X		1

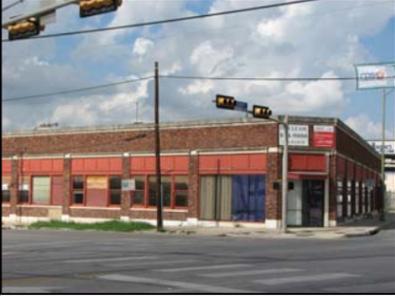
8	1101 Broadway (1101-1105 Broadway) <b>Standard Sanitary Manufacturing Showroom</b>

The single-story, brick commercial building at the corner of Broadway and Jones Avenue was constructed in 1923. It functioned as the Standard Sanitary Manufacturing Company building and showroom. It was designed by George Willis, a San Antonio architect who studied briefly under renowned architect Frank Lloyd Wright in Chicago, and later served as head draftsman under prolific San Antonio architect Atlee B. Ayres. Willis is perhaps best known in San Antonio for the design of the Milam Building on Travis Street. Abstract decorative features along the cornice and lintels of the Broadway building are indicative of Willis's work. Although the front entrance and windows along the Broadway façade have been replaced, many original windows along the Jones Avenue elevation have been retained. The original transom openings remain in place. The warehouse facility behind the main building was replaced at some time and is not being considered for designation. Although not associated with the automobile industry, the building is still a significant example of the type of early twentieth century commercial construction that occurred along Broadway and retains a high level of architectural integrity of design and workmanship.	<b>35-607 (b) 1.</b> Its value as a visible or archeological reminder of the cultural heritage of the community, or national event: early 20 <sup>th</sup> century commercial development; <b>35-607 (b) 4.</b> Its identification as the work of a master builder, designer, architect, or landscape architect whose individual work has influenced the development of the community, county, state, or nation: George Willis <b>35-607 (b) 5.</b> Its embodiment of distinguishing characteristics of an architectural style valuable for the study of a period, type, method of construction, or use of indigenous materials; <b>35-607 (b) 7.</b> Its unique location or singular physical characteristics that make it an established or familiar visual feature: part of the early 20th century commercial development of the Broadway corridor; <b>35-607 (b) 8.</b> Its historical, architectural, or cultural integrity of location, design, and workmanship; <b>35-607 (b) 11.</b> It is distinctive in character, interest, or value; strongly exemplifies the cultural, economic, social, ethnic, or historical heritage of San Antonio, Texas, or the United States: early 20 <sup>th</sup> century commercial development of the city; <b>35-607 (b) 12.</b> It is an important example of a particular architectural type or specimen: early 20 <sup>th</sup> century commercial construction	X	X	Owner opposed	2

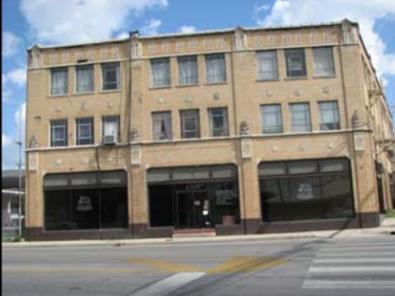
9	1100 Broadway <b>Sanderson Motors - Southern Music Building</b>

The three-story brick commercial building at the corner of Broadway and Jones Avenue was constructed ca. 1926. It originally served as the Sanderson Motor Company building, a Hudson and Essex automobile dealership and showroom. It is best known, however, as the home of Southern Music, which occupied the space beginning in 1950. The company sold a very large catalog of sheet music, as well as owning, publishing, printing, and packaging their own music. Southern Music held over 5000 music titles. Southern Music featured a hallmark sign, now removed, of a giant neon music note on the Broadway façade. The building features Gothic-revival influenced detailing such as the shields over the window openings and geometric terra-cotta motifs on the brick pilasters and above the third floor windows. Although the ground floor windows have been replaced, the two upper floors have retained their original metal windows. Overall, the property retains high architectural integrity of design and workmanship. It is also significant for its association with both the early twentieth century automobile industry along the Broadway corridor as well as its lengthy association with Southern Music.	<b>35-607 (b) 1.</b> Its value as a visible or archeological reminder of the cultural heritage of the community, or national event: automobile industry and early 20 <sup>th</sup> century commercial development; <b>35-607 (b) 5.</b> Its embodiment of distinguishing characteristics of an architectural style valuable for the study of a period, type, method of construction, or use of indigenous materials; <b>35-607 (b) 7.</b> Its unique location or singular physical characteristics that make it an established or familiar visual feature: part of the automobile corridor of Broadway; part of the early 20th century commercial development of the Broadway corridor; <b>35-607 (b) 8.</b> Its historical, architectural, or cultural integrity of location, design, and workmanship; <b>35-607 (b) 11.</b> It is distinctive in character, interest, or value; strongly exemplifies the cultural, economic, social, ethnic, or historical heritage of San Antonio, Texas, or the United States: automobile industry (culture) and early 20 <sup>th</sup> century commercial development of the city; <b>35-607 (b) 12.</b> It is an important example of a particular architectural type or specimen: early 20 <sup>th</sup> century commercial construction	X	X	Owner opposed	2

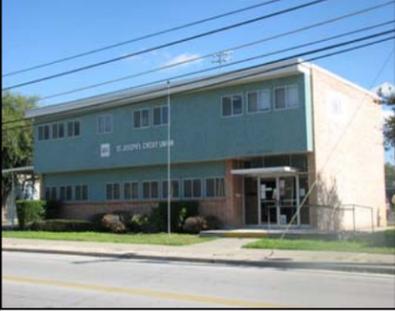
Property Address	Photo	Summary and Recommendation	Eligibility Criteria	OHP Staff Recommend	HDRC Recommend	Owner Response	Council District
10	802 Brooklyn

The two-story mid-twentieth century commercial structure at Brooklyn and Dallas Street was constructed ca. 1965. It was purchased by St. Joseph's Credit Union in 1977, and the credit union remains in the building today. Indicative mid-twentieth century features of the building include the mosaic tile on the second floor façade, the flat roof and cantilevered entrance awning, and the horizontal bands of windows. The building retains high architectural integrity of design, materials, and workmanship, and it remains an intact example of 1960s commercial design.	<p><b>35-607 (b) 1.</b> Its value as a visible or archeological reminder of the cultural heritage of the community, or national event: mid 20<sup>th</sup> century commercial development;</p> <p><b>35-607 (b) 5.</b> Its embodiment of distinguishing characteristics of an architectural style valuable for the study of a period, type, method of construction, or use of indigenous materials;</p> <p><b>35-607 (b) 7.</b> Its unique location or singular physical characteristics that make it an established or familiar visual feature: part of the mid 20th century commercial development of the area;</p> <p><b>35-607 (b) 8.</b> Its historical, architectural, or cultural integrity of location, design, materials, and workmanship;</p> <p><b>35-607 (b) 11.</b> It is distinctive in character, interest, or value; strongly exemplifies the cultural, economic, social, ethnic, or historical heritage of San Antonio, Texas, or the United States: mid 20<sup>th</sup> century commercial development of the city;</p> <p><b>35-607 (b) 12.</b> It is an important example of a particular architectural type or specimen: mid 20<sup>th</sup> century commercial construction</p>	X	X		1

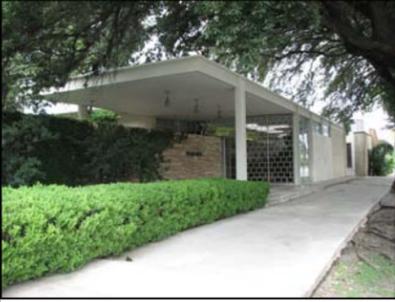
11	621 N Alamo Zander Building

The single-story, mid-twentieth century commercial structure at 621 N Alamo was constructed ca. 1958 for Liston Zander Credit Company, an auto finance company that served the automobile corridor along Broadway. Indicative mid-twentieth century features of the façade include the flat roof, low horizontal massing, flat portico roof extending from the entrance, and decorative screening wall. The building retains high architectural integrity of design, materials, and workmanship, and it remains an intact example of mid-twentieth century modern commercial construction.	<p><b>35-607 (b) 1.</b> Its value as a visible or archeological reminder of the cultural heritage of the community, or national event: automobile industry and mid 20<sup>th</sup> century commercial development;</p> <p><b>35-607 (b) 5.</b> Its embodiment of distinguishing characteristics of an architectural style valuable for the study of a period, type, method of construction, or use of indigenous materials;</p> <p><b>35-607 (b) 7.</b> Its unique location or singular physical characteristics that make it an established or familiar visual feature: part of the automobile corridor of Broadway; part of the mid 20th century commercial development of the area;</p> <p><b>35-607 (b) 8.</b> Its historical, architectural, or cultural integrity of location, design, materials, and workmanship;</p> <p><b>35-607 (b) 11.</b> It is distinctive in character, interest, or value; strongly exemplifies the cultural, economic, social, ethnic, or historical heritage of San Antonio, Texas, or the United States: automobile industry (culture) and mid 20<sup>th</sup> century commercial development of the city;</p> <p><b>35-607 (b) 12.</b> It is an important example of a particular architectural type or specimen: mid 20<sup>th</sup> century commercial construction</p>	X	X	Owner opposed	1

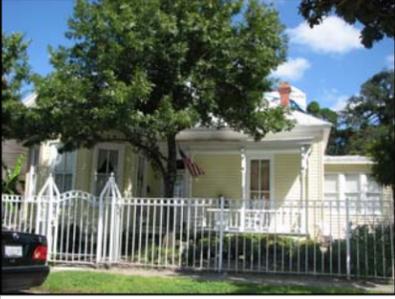
12	502 8 <sup>th</sup> Street

The Queen Anne style residence at 502 8 <sup>th</sup> Street appears to have been documented on a 1904 Sanborn map, but the deed records suggest construction after 1917. The structure remains a residence and maintains a high degree of architectural integrity of design, materials, and workmanship. It remains an intact and architecturally significant example of the type of early twentieth century residences that developed within the area.	<p><b>35-607 (b) 1.</b> Its value as a visible or archeological reminder of the cultural heritage of the community, or national event: early 20<sup>th</sup> century residential development;</p> <p><b>35-607 (b) 5.</b> Its embodiment of distinguishing characteristics of an architectural style valuable for the study of a period, type, method of construction, or use of indigenous materials;</p> <p><b>35-607 (b) 7.</b> Its unique location or singular physical characteristics that make it an established or familiar visual feature: part of the early 20th century residential development of the area;</p> <p><b>35-607 (b) 8.</b> Its historical, architectural, or cultural integrity of design, materials, and workmanship;</p> <p><b>35-607 (b) 11.</b> It is distinctive in character, interest, or value; strongly exemplifies the cultural, economic, social, ethnic, or historical heritage of San Antonio, Texas, or the United States: early 20<sup>th</sup> century residential development of the city;</p> <p><b>35-607 (b) 12.</b> It is an important example of a particular architectural type or specimen: early 20<sup>th</sup> century residential design (Queen Anne)</p>	X	X	Owner supports	1

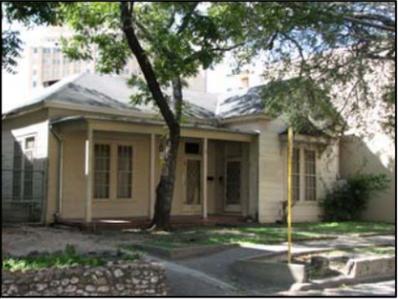
Property Address	Photo	Summary and Recommendation	Eligibility Criteria	OHP Staff Recommend	HDRC Recommend	Owner Response	Council District
13	219 4th St

The former residence at 219 4 <sup>th</sup> Street was constructed ca. 1885 and is documented on an 1896 Sanborn map. The lot was sold to Olive Coulson in 1885, with a mechanic lien issued that same year. The property was sold to Francis Smith in 1892. It was then sold to Mary A. Rigsby in 1899. Mrs. Mary Rigsby lived at the house in 1915. Mary Rigsby was the mother of William C. Rigsby and Nellie Rigsby (Mrs. Ben Hammond). Prominent San Antonio merchants William Rigsby and Ben Hammond were major investors in the development of the Highland Park area. Rigsby and Hammond streets are named for them. The property was owned by the Rigsby family until 1944. Despite asbestos siding, the house retains a high degree of architectural integrity of design and workmanship, and it is one of the oldest surviving residences identified within the area.	<p><b>35-607 (b) 1.</b> Its value as a visible or archeological reminder of the cultural heritage of the community, or national event: late 19<sup>th</sup>/early 20<sup>th</sup> century residential development;</p> <p><b>35-607 (b) 3.</b> Its identification with a person or persons who significantly contributed to the development of the community, county, state, or nation (Rigsby family);</p> <p><b>35-607 (b) 5.</b> Its embodiment of distinguishing characteristics of an architectural style valuable for the study of a period, type, method of construction, or use of indigenous materials;</p> <p><b>35-607 (b) 7.</b> Its unique location or singular physical characteristics that make it an established or familiar visual feature: part of the late 19<sup>th</sup>/ early 20<sup>th</sup> century residential development of the area;</p> <p><b>35-607 (b) 8.</b> Its historical, architectural, or cultural integrity of design, and workmanship;</p> <p><b>35-607 (b) 11.</b> It is distinctive in character, interest, or value; strongly exemplifies the cultural, economic, social, ethnic, or historical heritage of San Antonio, Texas, or the United States: late 19<sup>th</sup>/ early 20<sup>th</sup> century residential development of the city;</p> <p><b>35-607 (b) 12.</b> It is an important example of a particular architectural type or specimen: late 19<sup>th</sup>/ early 20<sup>th</sup> century residential construction and one of oldest remaining homes within the area</p>	X	X		1

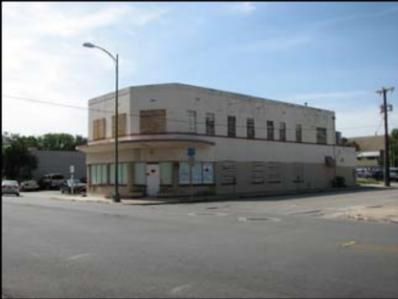
14	811 N St Mary's (815 N. St. Mary's)

The two-story commercial structure at the corner of N. St. Mary's and Richmond Avenue was constructed in 1950 according to notes on a 1951 Sanborn map. The curved awning on the façade is documented on the 1951 Sanborn map. The building is an intact example of late Moderne style commercial design. Original metal casement windows are visible below wooden louvers. The property retains architectural integrity of design, materials and workmanship. It remains an intact and significant example of mid-twentieth century Moderne style commercial design.	<p><b>35-607 (b) 1.</b> Its value as a visible or archeological reminder of the cultural heritage of the community, or national event: mid 20<sup>th</sup> century commercial development;</p> <p><b>35-607 (b) 5.</b> Its embodiment of distinguishing characteristics of an architectural style valuable for the study of a period, type, method of construction, or use of indigenous materials;</p> <p><b>35-607 (b) 7.</b> Its unique location or singular physical characteristics that make it an established or familiar visual feature: part of the mid 20<sup>th</sup> century commercial development of the area;</p> <p><b>35-607 (b) 8.</b> Its historical, architectural, or cultural integrity of location, design, materials, and workmanship;</p> <p><b>35-607 (b) 11.</b> It is distinctive in character, interest, or value; strongly exemplifies the cultural, economic, social, ethnic, or historical heritage of San Antonio, Texas, or the United States: mid 20<sup>th</sup> century commercial development of the city;</p> <p><b>35-607 (b) 12.</b> It is an important example of a particular architectural type or specimen: mid 20<sup>th</sup> century commercial construction (late Moderne style)</p>	X	X	Owner opposed	1

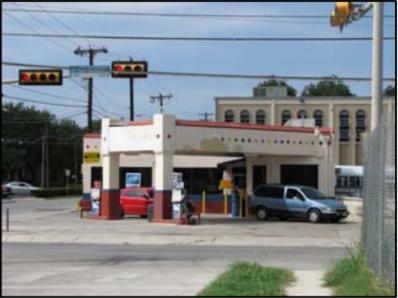
15	1201 N St Mary's Griffith Texaco Station

The former gas station at 1201 N. St. Mary's was constructed ca. 1930. In 1931 the Texas Company leased the property from Johnson Griffith, who had purchased it in 1928. The lease was renewed several times. In 1948 the property was sold to Abe Ellen Efron and Texas Co. leased the property from Efron beginning in 1958. It is documented as a filling station on a 1951 Sanborn map. The property retains architectural integrity of design and workmanship, and it continues to convey its significance as an early twentieth century corner gas station that would have been common throughout the city.	<p><b>35-607 (b) 1.</b> Its value as a visible or archeological reminder of the cultural heritage of the community, or national event: development of the automobile/transportation industry and early 20<sup>th</sup> century commercial development;</p> <p><b>35-607 (b) 5.</b> Its embodiment of distinguishing characteristics of an architectural style valuable for the study of a period, type, method of construction, or use of indigenous materials;</p> <p><b>35-607 (b) 7.</b> Its unique location or singular physical characteristics that make it an established or familiar visual feature: part of the early 20<sup>th</sup> century commercial development of the area;</p> <p><b>35-607 (b) 8.</b> Its historical, architectural, or cultural integrity of location, design, and workmanship;</p> <p><b>35-607 (b) 11.</b> It is distinctive in character, interest, or value; strongly exemplifies the cultural, economic, social, ethnic, or historical heritage of San Antonio, Texas, or the United States: automobile industry (culture) and early 20<sup>th</sup> century commercial development;</p> <p><b>35-607 (b) 12.</b> It is an important example of a particular architectural type or specimen: early 20<sup>th</sup> century commercial construction (one of the remaining corner gas station that were once prevalent throughout the city)</p>	X	X		1

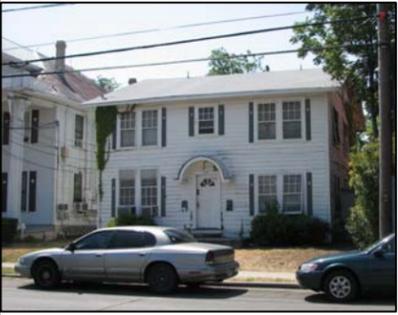
Property Address	Photo	Summary and Recommendation	Eligibility Criteria	OHP Staff Recommend	HDRC Recommend	Owner Response	Council District
16	510 Quincy

The two-story, Colonial Revival style house at 510 Quincy appears to have been constructed ca. 1935. The lot was purchased in 1908 by Hannah Blum, but it contained a structure with a different footprint per Sanborn maps. The property was sold by Blum in 1934. The existing house was either constructed shortly after this time or the original house on the property was extensively remodeled. By 1951, the existing property was identified as apartments. The house remains one of three examples of early twentieth century residential construction remaining within this block of Quincy. It retains high architectural integrity of design, materials, and workmanship, with original wood siding and wood windows. It remains an intact and architecturally significant example of the type of early twentieth century residences that developed within the area.	<b>35-607 (b) 1.</b> Its value as a visible or archeological reminder of the cultural heritage of the community, or national event: early 20 <sup>th</sup> century residential development; <b>35-607 (b) 5.</b> Its embodiment of distinguishing characteristics of an architectural style valuable for the study of a period, type, method of construction, or use of indigenous materials; <b>35-607 (b) 7.</b> Its unique location or singular physical characteristics that make it an established or familiar visual feature: early 20th century residential development of the area; <b>35-607 (b) 8.</b> Its historical, architectural, or cultural integrity of location, design, materials, and workmanship; <b>35-607 (b) 11.</b> It is distinctive in character, interest, or value; strongly exemplifies the cultural, economic, social, ethnic, or historical heritage of San Antonio, Texas, or the United States: early 20 <sup>th</sup> century residential development of the city; <b>35-607 (b) 12.</b> It is an important example of a particular architectural type or specimen: early 20 <sup>th</sup> century residential design (Colonial Revival)	X	X		1

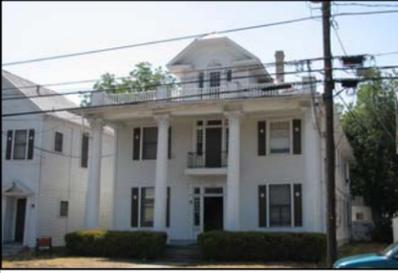
17	512 Quincy Cleveland Apartments

The two-story, Classical Revival style residence at 512 Quincy was constructed ca. 1915 apparently as an apartment house. It was reportedly built for Mary Elizabeth Cleveland, who was identified as the owner in 1920. Renters were also identified for the property at that time. The 1927-28 City Directory identifies it as the Cleveland Apartments. According to a newspaper article, it was the first apartment house constructed in San Antonio. The house is one of three examples of early twentieth century residential construction remaining within this block of Quincy. It retains high architectural integrity of design, materials and workmanship, with original wood siding, mostly original wood windows, original door surrounds (with side lights and transoms) at both levels, and original wood columns and roof balustrade. It remains an intact and architecturally significant example of the type of early twentieth century residences that developed within the area.	<b>35-607 (b) 1.</b> Its value as a visible or archeological reminder of the cultural heritage of the community, or national event: early 20 <sup>th</sup> century residential development; <b>35-607 (b) 5.</b> Its embodiment of distinguishing characteristics of an architectural style valuable for the study of a period, type, method of construction, or use of indigenous materials; <b>35-607 (b) 7.</b> Its unique location or singular physical characteristics that make it an established or familiar visual feature: early 20th century residential development of the area; <b>35-607 (b) 8.</b> Its historical, architectural, or cultural integrity of location, design, materials, and workmanship; <b>35-607 (b) 11.</b> It is distinctive in character, interest, or value; strongly exemplifies the cultural, economic, social, ethnic, or historical heritage of San Antonio, Texas, or the United States: early 20 <sup>th</sup> century residential development of the city; <b>35-607 (b) 12.</b> It is an important example of a particular architectural type or specimen: early 20 <sup>th</sup> century residential design (Classical Revival)	X	X		1

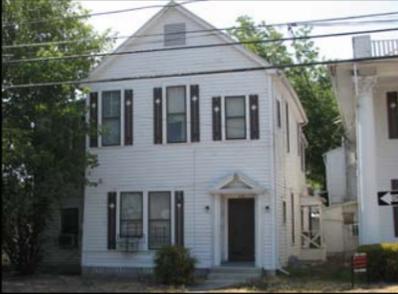
18	516 Quincy

The two-story Colonial Revival style residence at 516 Quincy was constructed ca. 1900. It is documented on 1904 and 1912 Sanborn maps but appears to have been significantly modified after this time. The property was occupied by renters from 1920-1924, and in 1927-28 it was owned by H.L. Miller, son-in-law of Mary Elizabeth Cleveland who owned the property next door at 512 Quincy. In 1951 the property is identified as apartments. Despite early twentieth century modifications, the building remains an intact example of the Colonial Revival style and is one of three examples of early twentieth century residential construction remaining within this block of Quincy. It retains high architectural integrity of materials and workmanship, with original wood siding, wood windows, and an original wood door surround. It remains an intact and architecturally significant example of the type of early twentieth century residences that developed within the area.	<b>35-607 (b) 1.</b> Its value as a visible or archeological reminder of the cultural heritage of the community, or national event: early 20 <sup>th</sup> century residential development; <b>35-607 (b) 5.</b> Its embodiment of distinguishing characteristics of an architectural style valuable for the study of a period, type, method of construction, or use of indigenous materials; <b>35-607 (b) 7.</b> Its unique location or singular physical characteristics that make it an established or familiar visual feature: early 20th century residential development of the area; <b>35-607 (b) 8.</b> Its historical, architectural, or cultural integrity of location, materials, and workmanship; <b>35-607 (b) 11.</b> It is distinctive in character, interest, or value; strongly exemplifies the cultural, economic, social, ethnic, or historical heritage of San Antonio, Texas, or the United States: early 20 <sup>th</sup> century residential development of the city; <b>35-607 (b) 12.</b> It is an important example of a particular architectural type or specimen: early 20 <sup>th</sup> century residential design (Colonial Revival)	X	X		1

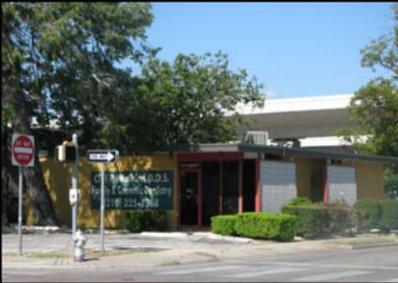
19	523 Quincy Manhoff Medical Building

According to a newspaper article and deed research, the mid-twentieth century commercial building was constructed in 1960 to serve as medical offices for L. J. Manhoff & C. M. Manhoff. Indicative mid-twentieth century features of the building include the flat roof, low profile, and decorative concrete screening walls on the façade. The property retains high architectural integrity of design, materials, and workmanship. It remains an intact and significant example of mid-twentieth century modern commercial design.	<b>35-607 (b) 1.</b> Its value as a visible or archeological reminder of the cultural heritage of the community, or national event: mid 20 <sup>th</sup> century commercial development; <b>35-607 (b) 5.</b> Its embodiment of distinguishing characteristics of an architectural style valuable for the study of a period, type, method of construction, or use of indigenous materials; <b>35-607 (b) 7.</b> Its unique location or singular physical characteristics that make it an established or familiar visual feature: part of the mid 20th century commercial development of the area; <b>35-607 (b) 8.</b> Its historical, architectural, or cultural integrity of location, design, materials, and workmanship; <b>35-607 (b) 11.</b> It is distinctive in character, interest, or value; strongly exemplifies the cultural, economic, social, ethnic, or historical heritage of San Antonio, Texas, or the United States: mid 20 <sup>th</sup> century commercial development of the city; <b>35-607 (b) 12.</b> It is an important example of a particular architectural type or specimen: mid 20 <sup>th</sup> century commercial construction	X	X		1

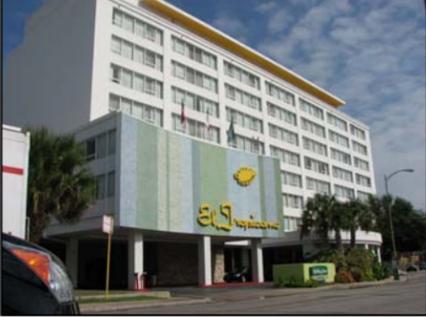
Property Address	Photo	Summary and Recommendation	Eligibility Criteria	OHP Staff Recommend	HDRC Recommend	Owner Response	Council District
20	110 Lexington El Tropicano Hotel

The El Tropicano Hotel was constructed in 1962 for real estate developer R.E. Dumas Milner of Jackson, Mississippi. A newspaper article in 1962 noted that the luxury “Motor-Hotel” featured a nine-story street-side façade, a 15,000 square foot pool deck at the second story level, the Cascades main dining room, a Petit Café snack bar, the Fontana Club (a private dining club), the Continental Ballroom, three convention rooms, a children’s nursery with a registered nurse on staff, and a palm tree lined arcade of shops on the ground floor facing the San Antonio River with a stream meandering through the building. The area proposed for landmark designation does not include the non-contributing parking garage. Today, despite interior alterations over time, the building continues to remain an intact example of mid-twentieth century modern hotel design and still functions as the Holiday Inn El Tropicano Hotel.	<b>35-607 (b) 1.</b> Its value as a visible or archeological reminder of the cultural heritage of the community, or national event: tourism industry and mid 20 <sup>th</sup> century commercial development along the River; <b>35-607 (b) 5.</b> Its embodiment of distinguishing characteristics of an architectural style valuable for the study of a period, type, method of construction, or use of indigenous materials; <b>35-607 (b) 7.</b> Its unique location or singular physical characteristics that make it an established or familiar visual feature: part of the mid 20th century commercial development of the area and River; <b>35-607 (b) 8.</b> Its historical, architectural, or cultural integrity of location, design, materials, and workmanship; <b>35-607 (b) 11.</b> It is distinctive in character, interest, or value; strongly exemplifies the cultural, economic, social, ethnic, or historical heritage of San Antonio, Texas, or the United States: tourism industry (culture); mid 20 <sup>th</sup> century commercial development of the city; <b>35-607 (b) 12.</b> It is an important example of a particular architectural type or specimen: mid 20 <sup>th</sup> century commercial construction	X	X		1

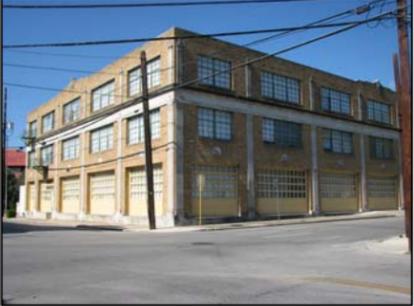
21	317 Lexington Goad Motor Company Building (Cadillac Lofts)

The former Goad Motor Company Building was constructed in 1927 for Thomas Jefferson Goad (1887-1970) as a Cadillac-LaSalle auto dealership. It was the first Cadillac dealership in San Antonio and served continuously in this capacity, although under different ownership, until 1996. The building was designed by San Antonio architect Harvey P. Smith (known for such projects as the Sunken Garden Theater in Brackenridge Park and restoration of the Spanish Governor’s Palace and Missions San Jose and Espada in the 1930s). Today, the Goad Motor Company Building has been converted into the Cadillac Lofts, so called for its automobile heritage. The property is listed in the National Register of Historic Places. It remains an intact and significant example of early twentieth century commercial construction that has been adapted to modern residential use.	<b>35-607 (b) 1.</b> Its value as a visible or archeological reminder of the cultural heritage of the community, or national event: automobile industry and early 20 <sup>th</sup> century commercial development; <b>35-607 (b) 4.</b> Its identification as the work of a master builder, designer, architect, or landscape architect whose individual work has influenced the development of the community, county, state, or nation: Harvey P. Smith <b>35-607 (b) 5.</b> Its embodiment of distinguishing characteristics of an architectural style valuable for the study of a period, type, method of construction, or use of indigenous materials; <b>35-607 (b) 7.</b> Its unique location or singular physical characteristics that make it an established or familiar visual feature: part of the automobile industry; part of the early 20th century commercial development of the area; <b>35-607 (b) 8.</b> Its historical, architectural, or cultural integrity of location, design, materials, and workmanship; <b>35-607 (b) 11.</b> It is distinctive in character, interest, or value; strongly exemplifies the cultural, economic, social, ethnic, or historical heritage of San Antonio, Texas, or the United States: automobile industry (culture) and early 20 <sup>th</sup> century commercial development of the city; <b>35-607 (b) 12.</b> It is an important example of a particular architectural type or specimen: early 20 <sup>th</sup> century commercial construction	X	X	Owner supports	1

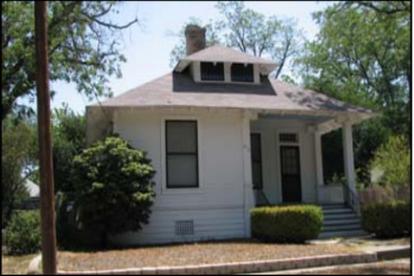
22	414 Atlanta

The bungalow residence at 414 Atlanta was constructed ca. 1910 and is identified on a 1912 Sanborn map. The house retains high architectural integrity of design, materials, and workmanship, with original wood siding, wood windows, and original doors surrounds (side lights and transoms). It remains an intact and architecturally significant example of the type of early twentieth century residences that developed within the area.	<b>35-607 (b) 1.</b> Its value as a visible or archeological reminder of the cultural heritage of the community, or national event: early 20 <sup>th</sup> century residential development; <b>35-607 (b) 5.</b> Its embodiment of distinguishing characteristics of an architectural style valuable for the study of a period, type, method of construction, or use of indigenous materials; <b>35-607 (b) 7.</b> Its unique location or singular physical characteristics that make it an established or familiar visual feature: early 20th century residential development of the area; <b>35-607 (b) 8.</b> Its historical, architectural, or cultural integrity of location, design, materials, and workmanship; <b>35-607 (b) 11.</b> It is distinctive in character, interest, or value; strongly exemplifies the cultural, economic, social, ethnic, or historical heritage of San Antonio, Texas, or the United States: early 20 <sup>th</sup> century residential development of the city; <b>35-607 (b) 12.</b> It is an important example of a particular architectural type or specimen: early 20 <sup>th</sup> century residential design (bungalow)	X	X		1

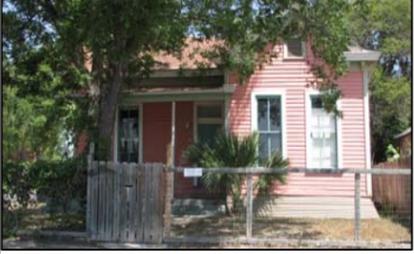
Property Address	Photo	Summary and Recommendation	Eligibility Criteria	OHP Staff Recommend	HDRC Recommend	Owner Response	Council District
23	901 Camden

The Folk Victorian style residence at 901 Camden was constructed ca. 1910. City directories indicate it was a rental property from 1911 through much of the early twentieth century. The house retains high architectural integrity of design, materials, and workmanship, with original wood siding, wood windows, and decorative dentils at the gable end. It remains an intact and architecturally significant example of the type of early twentieth century residences that developed within the area.	<b>35-607 (b) 1.</b> Its value as a visible or archeological reminder of the cultural heritage of the community, or national event: early 20 <sup>th</sup> century residential development; <b>35-607 (b) 5.</b> Its embodiment of distinguishing characteristics of an architectural style valuable for the study of a period, type, method of construction, or use of indigenous materials; <b>35-607 (b) 7.</b> Its unique location or singular physical characteristics that make it an established or familiar visual feature: early 20th century residential development of the area; <b>35-607 (b) 8.</b> Its historical, architectural, or cultural integrity of location, design, and workmanship; <b>35-607 (b) 11.</b> It is distinctive in character, interest, or value; strongly exemplifies the cultural, economic, social, ethnic, or historical heritage of San Antonio, Texas, or the United States: early 20 <sup>th</sup> century residential development of the city; <b>35-607 (b) 12.</b> It is an important example of a particular architectural type or specimen: early 20 <sup>th</sup> century residential design (Folk Victorian)	X	X		1

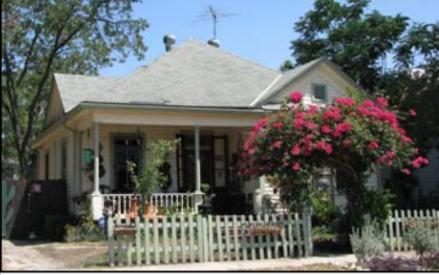
24	911 Camden

The Queen Anne style residence at 911 Camden was constructed ca. 1910 and appears on a 1912 Sanborn map. The house retains high architectural integrity of design, materials, and workmanship, with original wood siding and wood windows. It remains an intact and architecturally significant example of the type of early twentieth century residences that developed within the area.	<b>35-607 (b) 1.</b> Its value as a visible or archeological reminder of the cultural heritage of the community, or national event: early 20 <sup>th</sup> century residential development; <b>35-607 (b) 5.</b> Its embodiment of distinguishing characteristics of an architectural style valuable for the study of a period, type, method of construction, or use of indigenous materials; <b>35-607 (b) 7.</b> Its unique location or singular physical characteristics that make it an established or familiar visual feature: early 20th century residential development of the area; <b>35-607 (b) 8.</b> Its historical, architectural, or cultural integrity of location, design, materials, and workmanship; <b>35-607 (b) 11.</b> It is distinctive in character, interest, or value; strongly exemplifies the cultural, economic, social, ethnic, or historical heritage of San Antonio, Texas, or the United States: early 20 <sup>th</sup> century residential development of the city; <b>35-607 (b) 12.</b> It is an important example of a particular architectural type or specimen: early 20 <sup>th</sup> century residential design (Queen Anne)	X	X	Owner supports	1

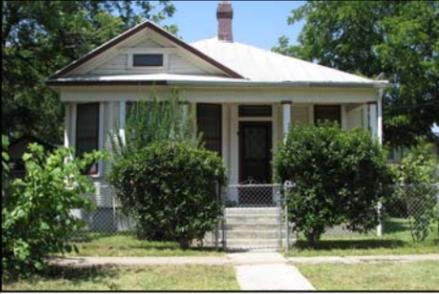
25	515 Erie

The Queen Anne style residence at 515 Erie appears to have been constructed ca. 1915, as it does not appear on a 1912 Sanborn map. It is identified in the 1915 City Directory. The house retains high architectural integrity of design, materials, and workmanship, with original wood siding, wood windows, original front door and transom, and metal roof. It remains an intact and architecturally significant example of the type of early twentieth century residences that developed within the area.	<b>35-607 (b) 1.</b> Its value as a visible or archeological reminder of the cultural heritage of the community, or national event: early 20 <sup>th</sup> century residential development; <b>35-607 (b) 5.</b> Its embodiment of distinguishing characteristics of an architectural style valuable for the study of a period, type, method of construction, or use of indigenous materials; <b>35-607 (b) 7.</b> Its unique location or singular physical characteristics that make it an established or familiar visual feature: early 20th century residential development of the area; <b>35-607 (b) 8.</b> Its historical, architectural, or cultural integrity of location, design, materials, and workmanship; <b>35-607 (b) 11.</b> It is distinctive in character, interest, or value; strongly exemplifies the cultural, economic, social, ethnic, or historical heritage of San Antonio, Texas, or the United States: early 20 <sup>th</sup> century residential development of the city; <b>35-607 (b) 12.</b> It is an important example of a particular architectural type or specimen: early 20 <sup>th</sup> century residential design (Queen Anne)	X	X	Owner opposed	1

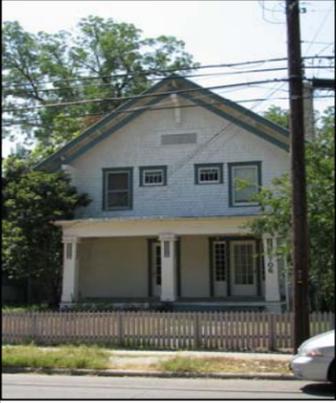
26	706 Quincy

The two-story residence with Craftsman-style influences at 706 Quincy was constructed ca. 1910 and appears on a 1912 Sanborn map. The lot was purchased in 1909 and a mechanics lien issued in 1910. The 1927 City Directory identifies it as a rental property. It was initially built as a single-family home but was converted to apartments sometime before 1950. The house retains high architectural integrity of design, materials, and workmanship, with original wood siding on the first floor, wood shingle siding on the second floor, wood windows, and Craftsman-style capitals on the porch posts. It remains an intact and architecturally significant example of the type of early twentieth century residences that developed within the area.	<b>35-607 (b) 1.</b> Its value as a visible or archeological reminder of the cultural heritage of the community, or national event: early 20 <sup>th</sup> century residential development; <b>35-607 (b) 5.</b> Its embodiment of distinguishing characteristics of an architectural style valuable for the study of a period, type, method of construction, or use of indigenous materials; <b>35-607 (b) 7.</b> Its unique location or singular physical characteristics that make it an established or familiar visual feature: early 20th century residential development of the area; <b>35-607 (b) 8.</b> Its historical, architectural, or cultural integrity of location, design, and workmanship; <b>35-607 (b) 11.</b> It is distinctive in character, interest, or value; strongly exemplifies the cultural, economic, social, ethnic, or historical heritage of San Antonio, Texas, or the United States: early 20 <sup>th</sup> century residential development of the city; <b>35-607 (b) 12.</b> It is an important example of a particular architectural type or specimen: early 20 <sup>th</sup> century residential design (Craftsman)	X	X		1

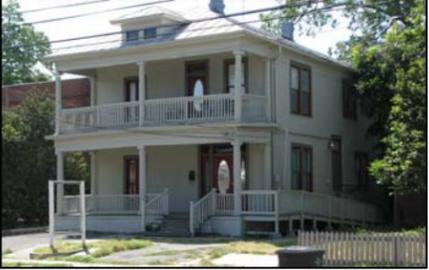
Property Address	Photo	Summary and Recommendation	Eligibility Criteria	OHP Staff Recommend	HDRC Recommend	Owner Response	Council District
27	708 Quincy

The two-story residence at 708 Quincy appears to have been constructed ca. 1915. It does not appear on a 1912 Sanborn map, but it is identified in the 1915 City Directory. By 1927, the property was owned by Mrs. Lena Heye. Mrs. Heye was a pianist and music teacher, and recitals were held at the home. She was chairman of the Fifth District of Junior Composers of Texas and active in San Antonio music clubs. Mrs. Heye lived and taught at the home as late as 1965 at the age of 88. Despite the replacement of both doors on the façade, the house retains high architectural integrity of design and workmanship, with original wood siding, wood windows, original porch columns, and metal roof. It remains an intact and architecturally significant example of the type of early twentieth century residences that developed within the area.	<b>35-607 (b) 1.</b> Its value as a visible or archeological reminder of the cultural heritage of the community, or national event: early 20 <sup>th</sup> century residential development; <b>35-607 (b) 5.</b> Its embodiment of distinguishing characteristics of an architectural style valuable for the study of a period, type, method of construction, or use of indigenous materials; <b>35-607 (b) 7.</b> Its unique location or singular physical characteristics that make it an established or familiar visual feature: early 20th century residential development of the area; <b>35-607 (b) 8.</b> Its historical, architectural, or cultural integrity of location, design, and workmanship; <b>35-607 (b) 11.</b> It is distinctive in character, interest, or value; strongly exemplifies the cultural, economic, social, ethnic, or historical heritage of San Antonio, Texas, or the United States: early 20 <sup>th</sup> century residential development of the city; <b>35-607 (b) 12.</b> It is an important example of a particular architectural type or specimen: early 20 <sup>th</sup> century residential design	X	X		1

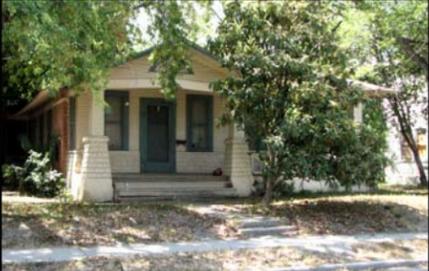
28	808 Quincy

The bungalow at 808 Quincy was constructed ca. 1925. An earlier home existed at the rear of the lot in 1912 facing Atlanta (per a 1912 Sanborn map), but this lot and the adjoining lot at 802 Quincy were reoriented toward Quincy sometime after 1912. The bungalow retains high architectural integrity of design, materials, and workmanship, with original wood siding, wood shingle skirting, wood windows, and battered porch supports. It remains an intact and architecturally significant example of the type of early twentieth century residences that developed within the area.	<b>35-607 (b) 1.</b> Its value as a visible or archeological reminder of the cultural heritage of the community, or national event: early 20 <sup>th</sup> century residential development; <b>35-607 (b) 5.</b> Its embodiment of distinguishing characteristics of an architectural style valuable for the study of a period, type, method of construction, or use of indigenous materials; <b>35-607 (b) 7.</b> Its unique location or singular physical characteristics that make it an established or familiar visual feature: early 20th century residential development of the area; <b>35-607 (b) 8.</b> Its historical, architectural, or cultural integrity of location, design, materials, and workmanship; <b>35-607 (b) 11.</b> It is distinctive in character, interest, or value; strongly exemplifies the cultural, economic, social, ethnic, or historical heritage of San Antonio, Texas, or the United States: early 20 <sup>th</sup> century residential development of the city; <b>35-607 (b) 12.</b> It is an important example of a particular architectural type or specimen: early 20 <sup>th</sup> century residential design (bungalow)	X	X		1

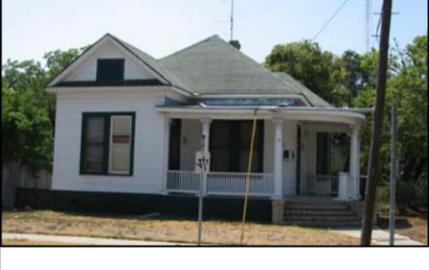
29	902 Quincy

The one-story Queen Anne style residence at 902 Quincy was constructed ca. 1905 and is identified on a 1912 Sanborn map. Although asbestos siding has been added to the exterior and the porch modified with concrete, the house retains architectural integrity of design and workmanship, with original wood windows and original wood porch columns and railings. It remains an architecturally significant example of the type of early twentieth century residences that developed within the area.	<b>35-607 (b) 1.</b> Its value as a visible or archeological reminder of the cultural heritage of the community, or national event: early 20 <sup>th</sup> century residential development; <b>35-607 (b) 5.</b> Its embodiment of distinguishing characteristics of an architectural style valuable for the study of a period, type, method of construction, or use of indigenous materials; <b>35-607 (b) 7.</b> Its unique location or singular physical characteristics that make it an established or familiar visual feature: early 20th century residential development of the area; <b>35-607 (b) 8.</b> Its historical, architectural, or cultural integrity of location, design, and workmanship; <b>35-607 (b) 11.</b> It is distinctive in character, interest, or value; strongly exemplifies the cultural, economic, social, ethnic, or historical heritage of San Antonio, Texas, or the United States: early 20 <sup>th</sup> century residential development of the city; <b>35-607 (b) 12.</b> It is an important example of a particular architectural type or specimen: early 20 <sup>th</sup> century residential design (Queen Anne)	X	X	Owner opposed	1

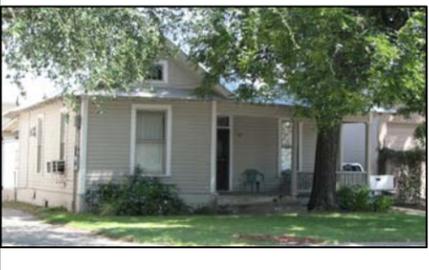
30	911 Quincy

The Queen Anne style residence at 911 Quincy was constructed ca. 1910 and appears on a 1912 Sanborn map. Based on City Directories, the house was a rental property in the early twentieth century. The house retains high architectural integrity of design, materials, and workmanship, with original wood siding, wood windows, and metal roof. It remains an intact and architecturally significant example of the type of early twentieth century residences that developed within the area.	<b>35-607 (b) 1.</b> Its value as a visible or archeological reminder of the cultural heritage of the community, or national event: early 20 <sup>th</sup> century residential development; <b>35-607 (b) 5.</b> Its embodiment of distinguishing characteristics of an architectural style valuable for the study of a period, type, method of construction, or use of indigenous materials; <b>35-607 (b) 7.</b> Its unique location or singular physical characteristics that make it an established or familiar visual feature: early 20th century residential development of the area; <b>35-607 (b) 8.</b> Its historical, architectural, or cultural integrity of location, design, materials, and workmanship; <b>35-607 (b) 11.</b> It is distinctive in character, interest, or value; strongly exemplifies the cultural, economic, social, ethnic, or historical heritage of San Antonio, Texas, or the United States: early 20 <sup>th</sup> century residential development of the city; <b>35-607 (b) 12.</b> It is an important example of a particular architectural type or specimen: early 20 <sup>th</sup> century residential design (Queen Anne)	X	X	Owner opposed	1

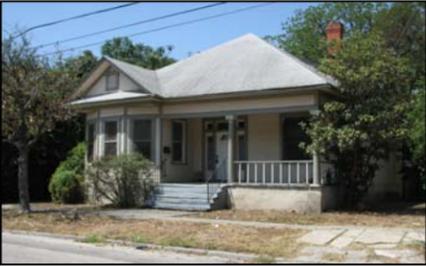
Property Address	Photo	Summary and Recommendation	Eligibility Criteria	OHP Staff Recommend	HDRC Recommend	Owner Response	Council District
31	309 Wilmington

The one-story Queen Anne style house at 309 Wilmington appears to have been constructed ca. 1915, as it does not appear on a 1912 Sanborn map. Based on City Directories, the house was a rental property in the early twentieth century. The house retains high architectural integrity of design, materials, and workmanship, with original wood siding, wood windows, original door surround (side lights and transom), decorative wood trim around the front bay windows, and original porch columns. It remains an intact and architecturally significant example of the type of early twentieth century residences that developed within the area.	<b>35-607 (b) 1.</b> Its value as a visible or archeological reminder of the cultural heritage of the community, or national event: early 20 <sup>th</sup> century residential development; <b>35-607 (b) 5.</b> Its embodiment of distinguishing characteristics of an architectural style valuable for the study of a period, type, method of construction, or use of indigenous materials; <b>35-607 (b) 7.</b> Its unique location or singular physical characteristics that make it an established or familiar visual feature: early 20th century residential development of the area; <b>35-607 (b) 8.</b> Its historical, architectural, or cultural integrity of location, design, materials, and workmanship; <b>35-607 (b) 11.</b> It is distinctive in character, interest, or value; strongly exemplifies the cultural, economic, social, ethnic, or historical heritage of San Antonio, Texas, or the United States: early 20 <sup>th</sup> century residential development of the city; <b>35-607 (b) 12.</b> It is an important example of a particular architectural type or specimen: early 20 <sup>th</sup> century residential design (Queen Anne)	X	X	Owner opposed	1

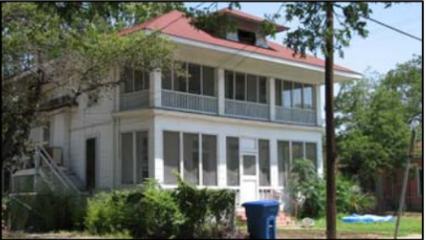
32	823 Camden

The two-story residence at 823 Camden appears to have been constructed ca. 1906 by J.F. Garland as a single-family home. It was sold in 1907, and the house appears on a 1912 Sanborn map. During the 1920s it was a rental property. In 1933, J.B. Rive's Radio Service Laboratory was located here. It was converted to multi-family by the 1940s. Despite both the upper and lower porch being enclosed with screens and most of the façade clad with asbestos, the house retains architectural integrity of design and workmanship, with original wood siding on the front façade, original wood windows, and an original front door and transom on the first floor. It remains an intact and architecturally significant example of the type of early twentieth century residences that developed within the area.	<b>35-607 (b) 1.</b> Its value as a visible or archeological reminder of the cultural heritage of the community, or national event: early 20 <sup>th</sup> century residential development; <b>35-607 (b) 5.</b> Its embodiment of distinguishing characteristics of an architectural style valuable for the study of a period, type, method of construction, or use of indigenous materials; <b>35-607 (b) 7.</b> Its unique location or singular physical characteristics that make it an established or familiar visual feature: early 20th century residential development of the area; <b>35-607 (b) 8.</b> Its historical, architectural, or cultural integrity of location, design, and workmanship; <b>35-607 (b) 11.</b> It is distinctive in character, interest, or value; strongly exemplifies the cultural, economic, social, ethnic, or historical heritage of San Antonio, Texas, or the United States: early 20 <sup>th</sup> century residential development of the city; <b>35-607 (b) 12.</b> It is an important example of a particular architectural type or specimen: early 20 <sup>th</sup> century residential design	X	X		1
