**Resolution for River North Landmarks  
Attachment A**

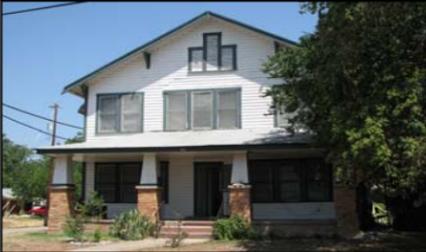
33	801 Camden

The two-story residence with Craftsman-style influences at 801 Camden was constructed ca. 1920 and replaced an earlier home identified on the lot in a 1912 Sanborn map. The single-family home was converted to apartments by 1950. The house retains high architectural integrity of design, material, and workmanship with original wood siding, wood windows, brackets, and battered Craftsman-style porch supports. It remains an intact and architecturally significant example of the type of early twentieth century residences that developed within the area.	<b>35-607 (b) 1.</b> Its value as a visible or archeological reminder of the cultural heritage of the community, or national event: early 20 <sup>th</sup> century residential development; <b>35-607 (b) 5.</b> Its embodiment of distinguishing characteristics of an architectural style valuable for the study of a period, type, method of construction, or use of indigenous materials; <b>35-607 (b) 7.</b> Its unique location or singular physical characteristics that make it an established or familiar visual feature: early 20th century residential development of the area; <b>35-607 (b) 8.</b> Its historical, architectural, or cultural integrity of location, design, materials, and workmanship; <b>35-607 (b) 11.</b> It is distinctive in character, interest, or value; strongly exemplifies the cultural, economic, social, ethnic, or historical heritage of San Antonio, Texas, or the United States: early 20 <sup>th</sup> century residential development of the city; <b>35-607 (b) 12.</b> It is an important example of a particular architectural type or specimen: early 20 <sup>th</sup> century residential design (Craftsman)	X	X		1

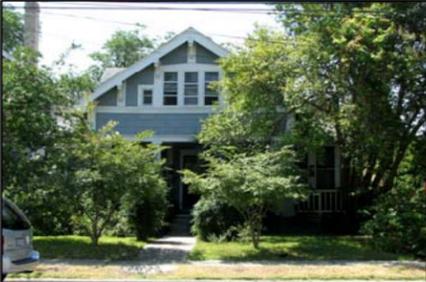
34	702 Quincy

The one-and-a-half story Craftsman style residence at 702 Quincy was constructed ca. 1910. It is identified on a 1912 Sanborn map. Initially built as a single family home, it was converted to apartments before 1950. Although replacement asbestos siding has been added on the exterior, the house retains architectural integrity of design and workmanship, with original wood windows, original wood brackets, some remaining Craftsman-style window screens on the side elevation, and wood porch supports and railing. It remains an intact and architecturally significant example of the type of early twentieth century residences that developed within the area.	<b>35-607 (b) 1.</b> Its value as a visible or archeological reminder of the cultural heritage of the community, or national event: early 20 <sup>th</sup> century residential development; <b>35-607 (b) 5.</b> Its embodiment of distinguishing characteristics of an architectural style valuable for the study of a period, type, method of construction, or use of indigenous materials; <b>35-607 (b) 7.</b> Its unique location or singular physical characteristics that make it an established or familiar visual feature: early 20th century residential development of the area; <b>35-607 (b) 8.</b> Its historical, architectural, or cultural integrity of location, design, and workmanship; <b>35-607 (b) 11.</b> It is distinctive in character, interest, or value; strongly exemplifies the cultural, economic, social, ethnic, or historical heritage of San Antonio, Texas, or the United States: early 20 <sup>th</sup> century residential development of the city; <b>35-607 (b) 12.</b> It is an important example of a particular architectural type or specimen: early 20 <sup>th</sup> century residential design (Craftsman)	X	X	Owner opposed	1

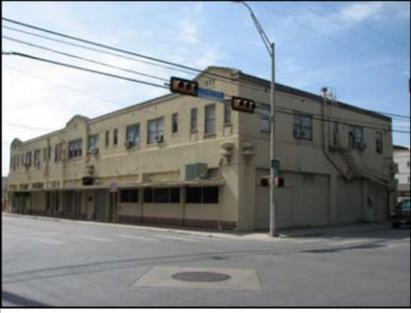
Property Address	Photo	Summary and Recommendation	Eligibility Criteria	OHP Staff Recommend	HDRC Recommend	Owner Response	Council District
35	833 N. St Mary's (841-845 N. St Mary's) Oakland Pharmacy

The two-story commercial structure at 833 (841-845) N. St. Mary's at the corner of St. Mary's and Lexington Avenue was constructed ca. 1920. The address changed from 129 Oakland to N. St. Mary's about 1925. According to an advertisement, the building served as the Oakland Drug Company/Oakland Pharmacy in the 1920s. Features include an original awning, original wood windows on the second floor, decorative tile banding below the roofline, and decorative urns supported by brackets along the façade. The building reflects a Spanish Eclectic influence. Modifications to the building include the enclosure of many of the window bays and the incorporation of modern replacement windows on the ground floor. Despite these alterations, the building represents a sophisticated example of early 20 <sup>th</sup> century commercial design.	<b>35-607 (b) 1.</b> Its value as a visible or archeological reminder of the cultural heritage of the community, or national event: early 20 <sup>th</sup> century commercial development; <b>35-607 (b) 5.</b> Its embodiment of distinguishing characteristics of an architectural style valuable for the study of a period, type, method of construction, or use of indigenous materials; <b>35-607 (b) 7.</b> Its unique location or singular physical characteristics that make it an established or familiar visual feature: part of the early 20th century commercial development of the area and its prominent corner location; <b>35-607 (b) 8.</b> Its historical, architectural, or cultural integrity of location, design, materials, and workmanship; <b>35-607 (b) 11.</b> It is distinctive in character, interest, or value; strongly exemplifies the cultural, economic, social, ethnic, or historical heritage of San Antonio, Texas, or the United States: early 20 <sup>th</sup> century commercial development of the city; <b>35-607 (b) 12.</b> It is an important example of a particular architectural type or specimen: early 20 <sup>th</sup> century commercial construction (Spanish Eclectic influence)	X	X		1

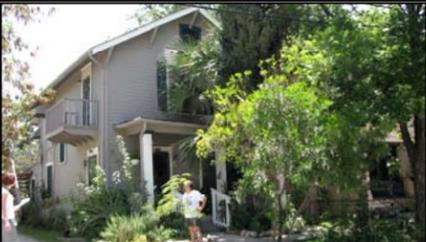
36	514 Erie

The two-story residence at 514 Erie was constructed ca. 1915. It does not appear on a 1912 Sanborn map, but it is listed in the 1915 City Directory as 516 Erie and occupied by a renter. It appears to have historically been a rent house. It has been slightly altered by the incorporation of a small balcony on the upper side elevation. Despite only this minor alteration, the property does not reflect significant stylistic features and does not appear to represent an architecturally significant example of early twentieth century residential design.	<b>Designation Committee Recommendation:</b> The property remains an intact example of the early 20 <sup>th</sup> century housing stock that once comprised the Madison Square neighborhood of River North. It is one of the few remaining houses on this street from this time period.		X	Owner opposed	1
37	323 Broadway (317-321 Broadway)

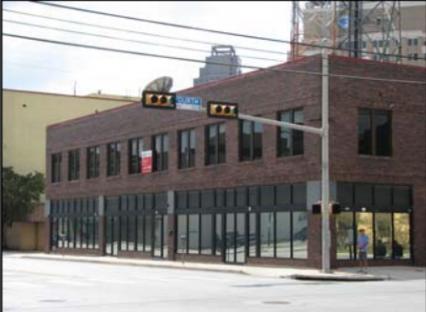
The two-story brick commercial building at 323 Broadway (317-321 Broadway) is located at the corner of Broadway and 4 <sup>th</sup> Street. It was constructed ca. 1920. In 1922 it served as the Yantis-Herpel Motor Company, and by the late 1920s it was identified as Yantis Motor Company (a Ford dealership). It is part of a cluster of former auto related buildings at this end of Broadway and served as part of this early twentieth century automobile corridor. The façade is utilitarian with little ornamentation, and the windows on both levels are modern replacements. Due to the window alterations, it no longer represents an architecturally significant or intact example of early 20 <sup>th</sup> century commercial design.	<b>Designation Committee Recommendation:</b> The property remains an intact example of an early 20 <sup>th</sup> century commercial structure along the Broadway corridor. It is significant for its relationship to the streetscape, for its proximity to other historic commercial buildings along Broadway, and for its association with the early automobile history of the Broadway corridor.		X	Owner opposed	1

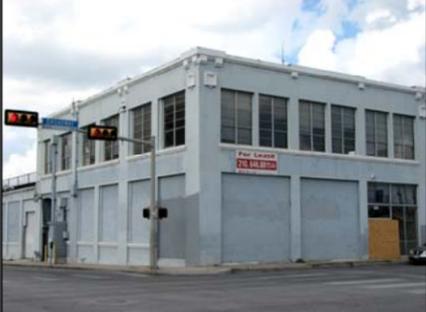
38	701 Broadway E. Y. White Dyeing and Cleaning Building

The two-story commercial building at 701 Broadway was constructed ca. 1912-1913 according to a 1951 Sanborn map. E.Y. White Dyeing and Cleaning Company occupied the building from 1913 through at least the late 1920s. The ground floor has been largely altered with the enclosure of most of the window bays. Due to these alterations, the property no longer appears to represent a significant or intact example of early twentieth century commercial design.	<b>Designation Committee Recommendation:</b> The property remains a significant example of an early 20th century commercial structure along the Broadway corridor.		X	Owner opposed	1

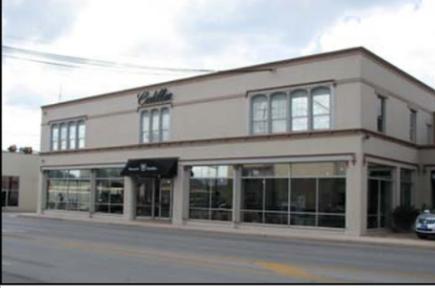
Property Address	Photo	Summary and Recommendation	Eligibility Criteria	OHP Staff Recommend	HDRC Recommend	Owner Response	Council District
39	801 Broadway (801-805 Broadway)

The two-story commercial building at 801 Broadway was constructed ca. 1926 according to a 1951 Sanborn map. It served as the Reo Motor Car Company of Texas in the late 1920s. Reo had previously opened at 234-36 Broadway in 1924 but moved to this location in 1926. Although very well maintained and still functioning as Cavendar Cadillac dealership, the building has been altered over time with the incorporation of replacement display windows along the ground floor and modern replacement sash windows on the second floor. The building features very minimal ornamentation, and due to the alteration of all windows, it no longer appears to represent a significant or intact example of early twentieth century commercial design.	<b>Designation Committee Recommendation:</b> The property remains a significant example of an early 20th century commercial structure. It is significant for its association with the automobile history of the Broadway corridor in the early to mid 20th century and for its continued operation as an automobile dealership today.		X	Owner opposed	1

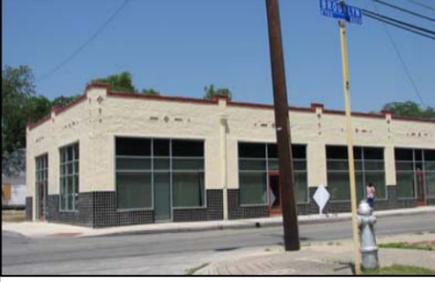
40	803 Brooklyn

The single-story commercial structure at 803 Brooklyn appears to have been constructed ca. 1925. It was occupied by North Side Cleaners and Laurel Petroleum Company (tire sales) in the late 1920s. In the early 1930s it functioned as Herber & Gold Auto repair. Although very well maintained, the building has been modified by the incorporation of modern replacement windows, and the heavy-handed application of the stucco cladding does not appear to be original. Due to these alterations, it no longer appears to represent a significant or intact example of early twentieth century commercial design.	<b>Designation Committee Recommendation:</b> The property remains a significant example of a single-story, early 20th century commercial structure.		X	Owner opposed	1
41	624 N. Alamo

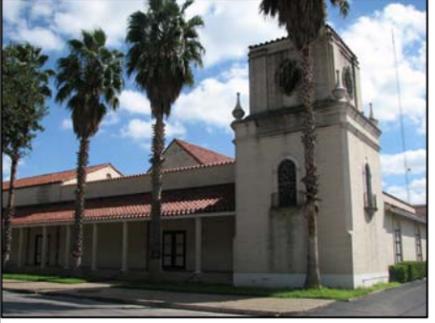
At least a portion of the building at 624 N. Alamo appears to have been constructed ca. 1930. It served as Shelley Funeral Home in the 1930s, and the building still functions as a funeral home of a different name today. Several additions and alterations have been incorporated over time, and the property no longer represents an architecturally significant example of 1930s architectural design.	<b>Designation Committee Recommendation:</b> The property remains an example of Spanish Revival style architecture of the early 20th century and is significant for its lengthy and continued association with the funeral home industry. Recommendation is for landmark designation of the historic tower element only, not the entire structure.		X		1

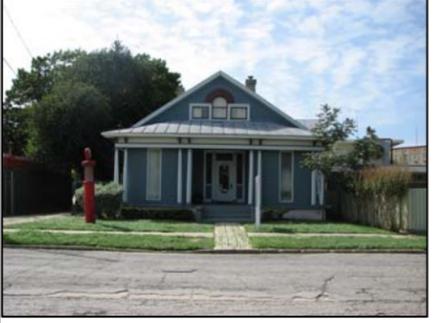
42	217 Arden Grove Evans House

The residence at 217 Arden Grove was constructed ca. 1910. A prior home at this location was documented on a 1904 Sanborn, but the existing footprint is identified on a 1912 Sanborn map. The property remained within the same family from 1908 through the 1970s. The original windows on the façade have been removed and the window openings reconfigured with smaller modern replacements. The gable window has also been altered. The former residential context of the neighborhood is no longer intact, and the house is the only residence remaining on the street and surrounded largely by vacant lots. Due to these alterations and the loss of the former residential context, the house no longer represents a significant or intact example of early 20 <sup>th</sup> residential design.	<b>Designation Committee Recommendation:</b> The property is one of the few remaining examples of early 20th century residences on this street and within this particular portion of the River North area.		X		1

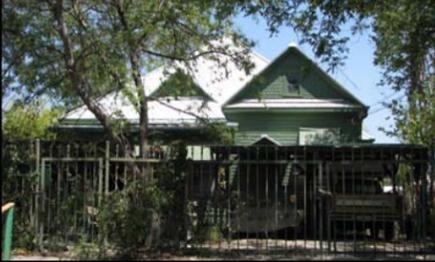
43	411 Dallas

The Queen Anne style residence at 411 Dallas was constructed ca. 1900 and is documented on a 1904 Sanborn map. It has been altered on the façade with the enclosure of the front porch, the incorporation of a new door opening, and the addition of a carport. It is one of the few remaining residences within this square block and is largely surrounded by commercial development. Due to these alterations and the loss of the former residential context, it no longer represents an architecturally significant or intact example of an early twentieth century residence.	<b>Designation Committee Recommendation:</b> The property is a remaining example of the type of late 19th-early 20th century housing stock that once comprised the Madison Square neighborhood.		X	Owner opposed	1
